### Case History

# Haste makes waste during balancing

by John Kingham, P.E.  
Machinery Diagnostics Services  
Engineer  
Bently Nevada Corporation

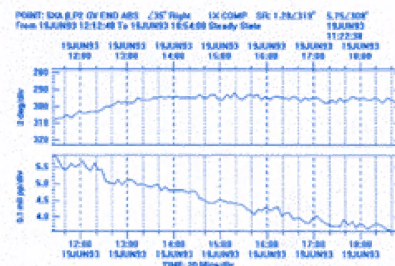
Figure 1  
APHT plot showing sag working itself out.

We had been on-site for 16 hours and the customer's regulations required us to leave the site for 8 hours. During that time, we left a 108 Data Acquisition Instrument sampling on a delta time mode. When we returned, vibration levels were lower (3.5 mils peak to peak 1X compensated absolute and 1.4 mils peak to peak 1X compensated relative). The Amplitude and Phase versus Time (APHT) plot (Figure 1) shows the change in vibration over time. It appears that the rotor bowed. During operation, the bow was relieved. Three minutes of time off turning gear would have saved a lot of speculation and probably a few gray hairs.

The unit was now operating out of the Alert range, satisfying the plant's personnel. As the load was increased, vibration levels decreased further. Rotating the rotor 180° and holding it there for a few more minutes before startup would have reduced the rotor thermal bow and the confusion it generated due to high "vibration" readings. ■
